RUBBER CRUMB LOSS ASSESSMENT FROM PLAY AREAS IN THE GREAT BARRIER REEF CATCHMENT

November 2021

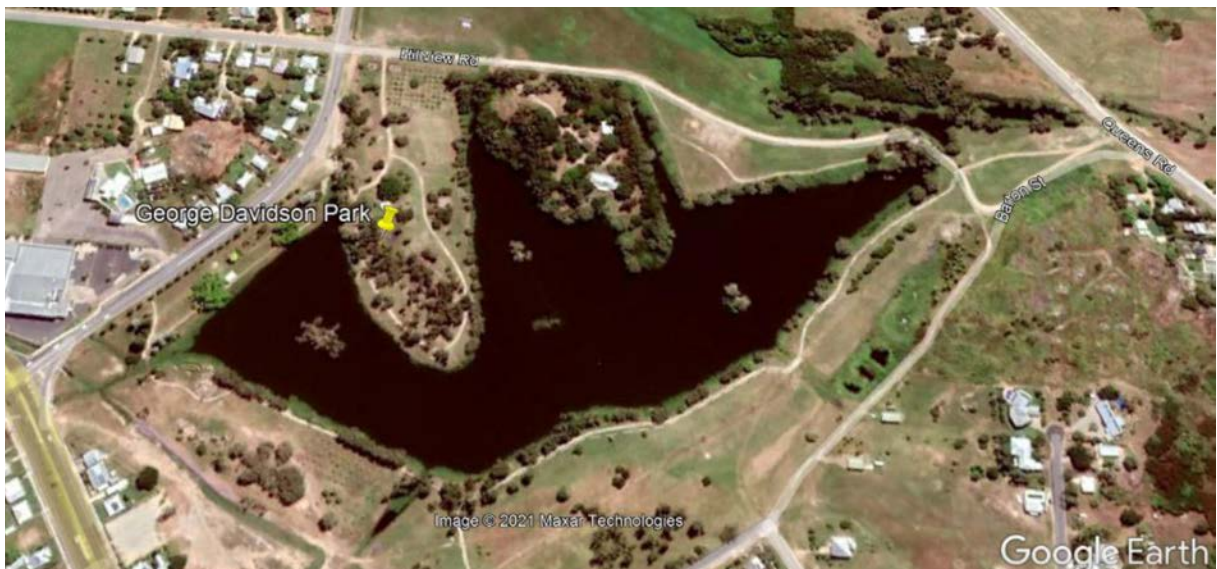
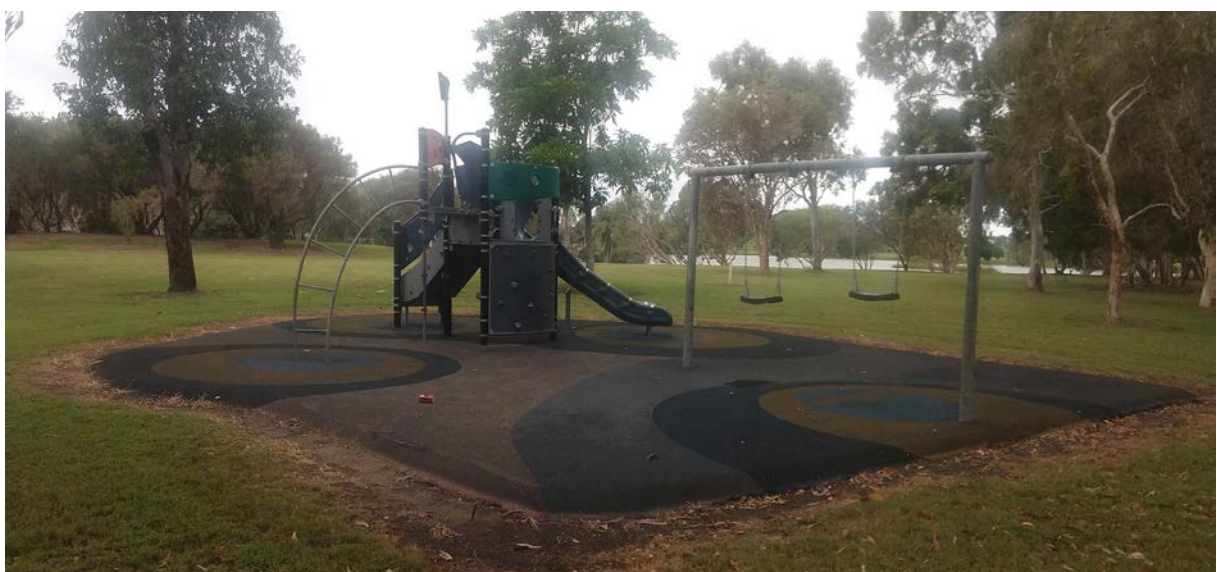
George Davidson Park (AKA Mullers Lagoon Park) play area is 11 m x 8 m containing a swing, slide and climbing equipment. The play area is immediately surrounded by grass and the nearest waterway is Mullers Lagoon, approximately 40 m from the play area. The play surface is approximately 10 years old and made up of light blue, orange/olive, grey and dark blue coloured rubber.

Sampling was conducted on the 25/04/2021. Moderate rainfall occurred (13.2 mm) in the 72 h before sampling. The condition of the play surface was graded as deteriorated with obvious signs of damage. The play area has limited shading. Twelve cores (8 cm diameter x 2 cm depth) were taken at 0 m, 2 m and 4 m away from the play area.

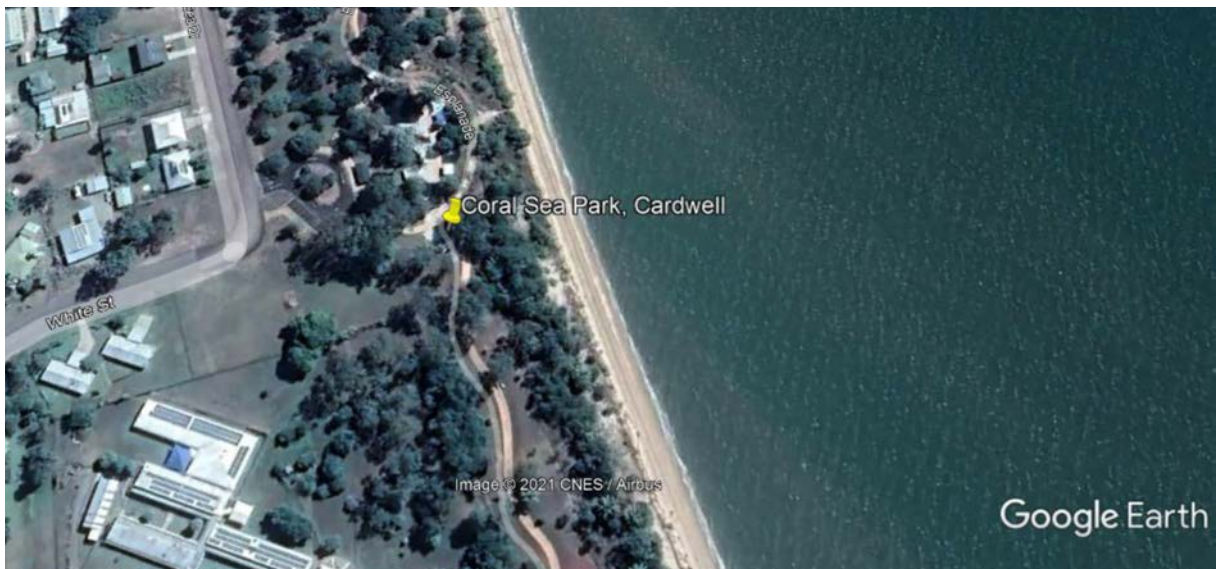
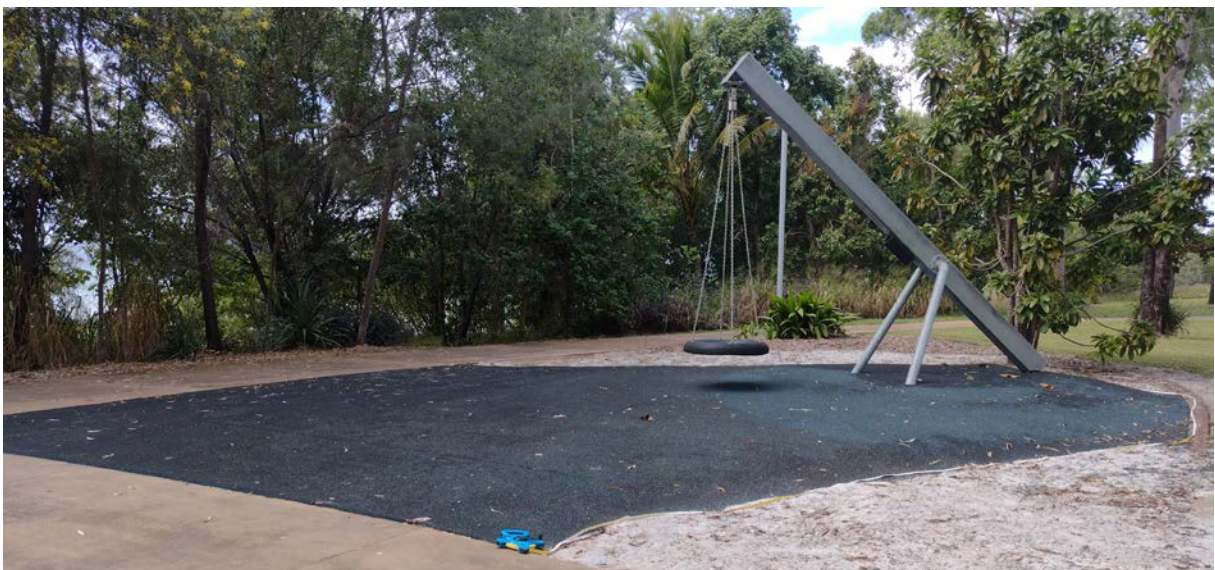
Coral Sea Park play area is 20 m x 18 m containing a swing and seat is only one of a selection of play areas in the park. The area is immediately surrounded by concrete path (30 %), sand (30 %), bark (20 %) and grass (20 %) and is 40 m from the beach. The play surface is approximately 8 years old and made up of predominantly dark blue coloured rubber.

Sampling was conducted on the 30/05/2021. Minimal rainfall occurred (0.2 mm) in the 72 h before sampling. The condition of the play surface was graded as deteriorated with obvious signs of damage. The play area has limited shading. Twelve cores (8 cm diameter x 2 cm depth) were taken at 0 m, 2 m and 4 m away from the play area from the sand/bark/grass areas.

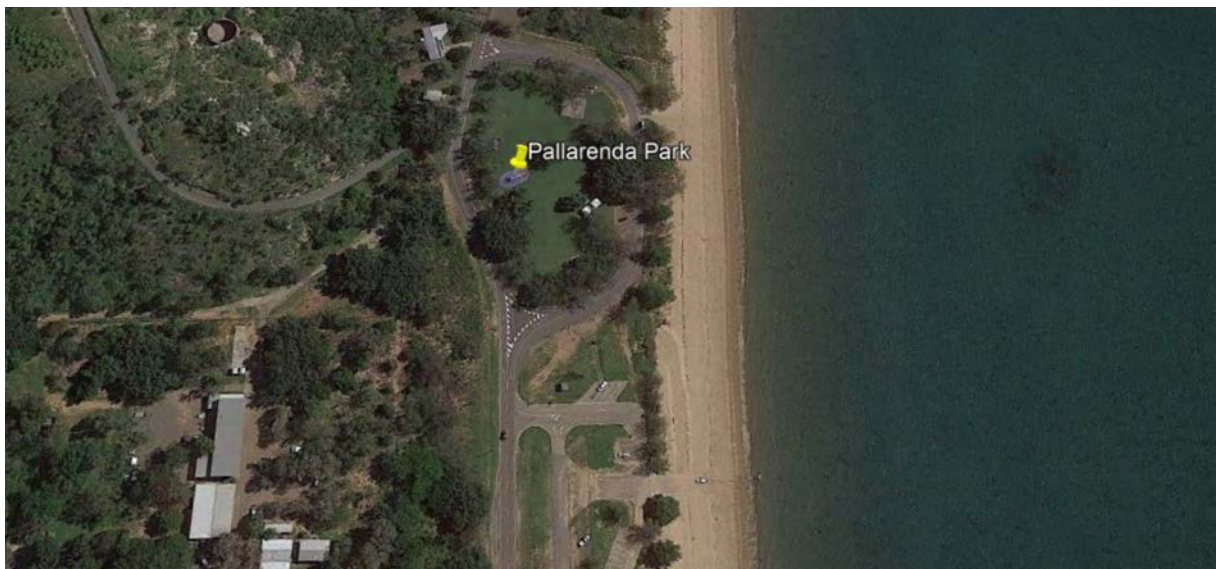
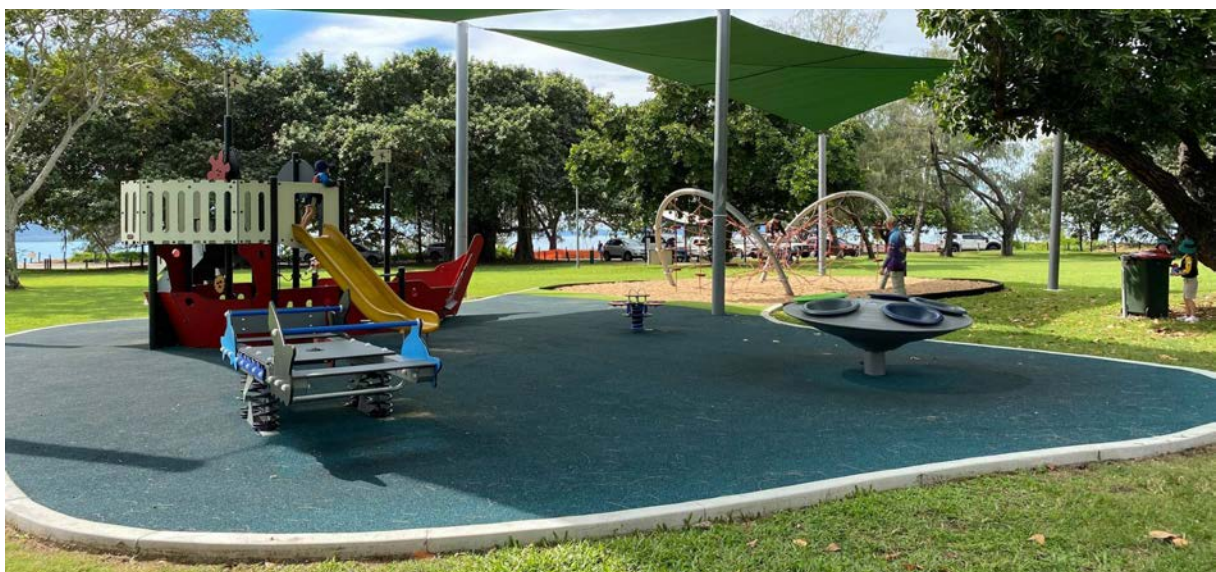
Pallarenda Park main play area is 15 m x 8 m containing a slide and climbing and other play equipment. The area is surrounded by a grass reserve and the beach is approximately 100 m from the play area. The play area has a shade cloth and a blue coloured rubber surface with a concrete edging around the periphery.

Sampling was conducted on the 08/05/2021. No rainfall occurred in the 72 h before sampling. The condition of the play surface was good with the surface relatively new (approximately 2 years old). The grass in the park had recently been mowed. Twelve cores (8 cm diameter x 2 cm depth) were taken at 0 m, 2 m and 4 m away from the play area.

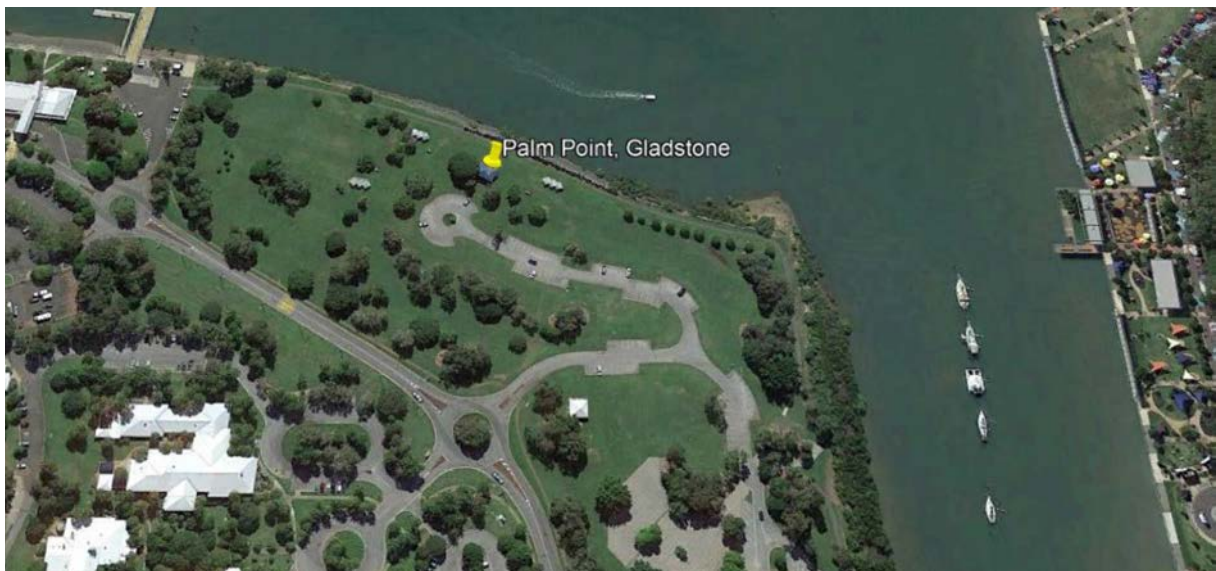
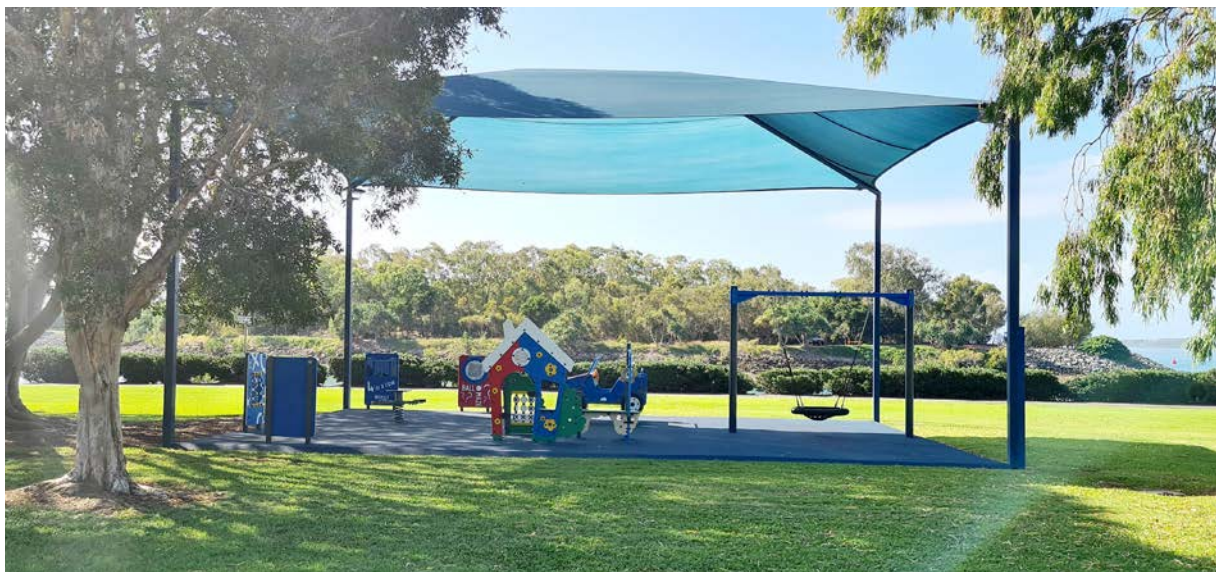
Palm Point Park is located at Gladstone Marina and managed by the Gladstone Ports Corporation. The play area is 22 m x 9 m and has toddlers play equipment (slides and climbing apparatus). The area is surrounded by a grass reserve and the harbour is approximately 24 m from the play area. The play surface is relatively new (3-4 years old) and made up of dark blue coloured rubber.

Sampling was conducted on the 11-12/05/2021. No rainfall occurred in the 72 h before sampling. The condition of the play surface was good with the grounds well maintained. A shade cloth covered the play area and it was a highly visited site for play groups. Twelve cores (8 cm diameter x 2 cm depth) were taken at 0 m, 2 m and 4 m away from the play area.

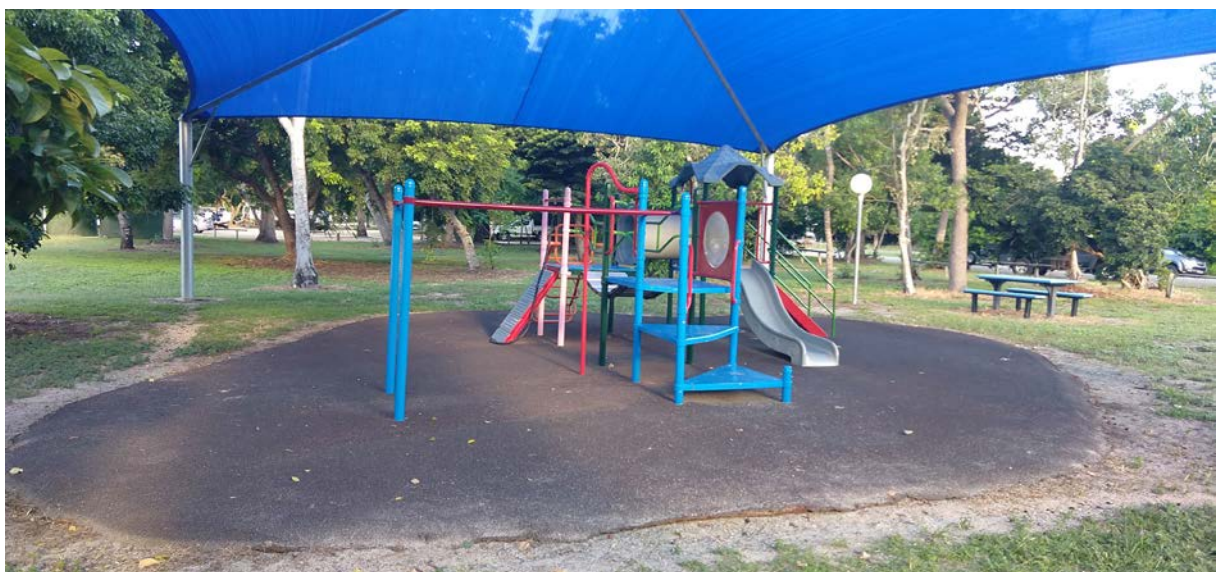
Dingo Beach play area has a circumference of 40 m and contains a slide and climbing equipment. The immediately area is surrounded by sand and grass and the beach is 54 m from the play area. The play surface is of unknown age and made up of a blue, black and terracotta (red) coloured rubber mix.

Sampling was conducted between the 10 - 18/04/2021. Minor rainfall occurred (5-10 mm) in the 72h before sampling. The condition of the play surface was graded as deteriorated with obvious signs of cracking. A shade cloth covered the site. Twelve cores (8 cm diameter x 2 cm depth) were taken at 0 m, 2 m and 4 m away from the play area.
