RUBBER CRUMB LOSS ASSESSMENT FROM PLAY AREAS IN THE GREAT BARRIER REEF CATCHMENT

November 2021

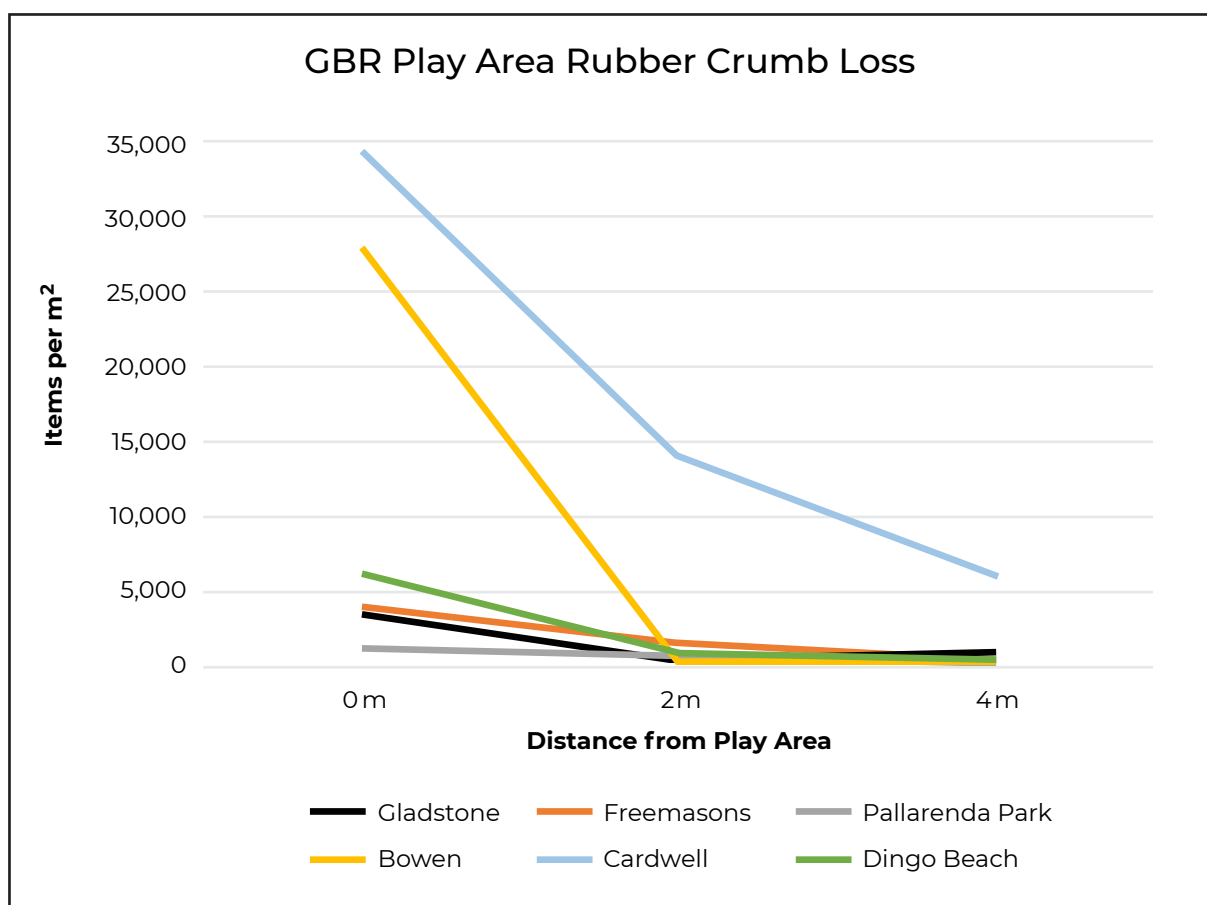
Figure 2: Play area rubber crumb loss at the 6 sites along the GBR

Sampling was undertaken between April and May 2021. Rubber loss was found at all sites with a decreasing trend away from each play area. Mean loss for all GBR sites was 12,890, 3081 and 1404 pieces per m² at 0 m, 2 m and 4 m, respectively (Fig. 2). This implies that for a play area with a 40 m circumference, over 1.2 million rubber crumb pieces are being lost on average out to 4 m, and for some individual sites this would be well over 2.5 million pieces.

The Cardwell and Bowen sites had the greatest rubber loss with levels over 25,000 per m² recorded adjoining the play area. The Pallarenda Park site in Townsville was the newest site studied and recorded the least loss. The age of the surface, the UV exposure, the frequency of use and type of surrounding surface (e.g. grass versus path or bare soil) are factors that can affect both loss and movement from a site.

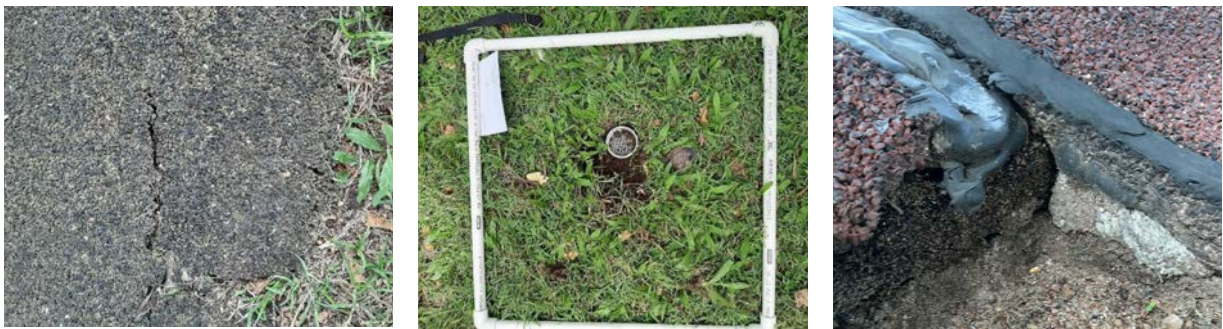
Sampling was conducted on the 17/04/2021. No rainfall occurred in the 72 h before sampling. The condition of the play surface was graded as deteriorated with obvious signs of damage. The play area is part shaded by a large tree. Ten cores (8 cm diameter x 2 cm depth) were taken at 0 m, 2 m and 4 m away from the play area.

- Moderately high rubber crumb loss close to the play area and proportional declines were found up to 4 metres from the site
- Shading may be reducing deterioration rates and grass adjoining the area further limits movement of rubber away
- Rubber was mostly 1 – 5 mm in size and a mix of colours related to the play area (56 % blue, 34 % black, 9.5 % red, 0.5 % green).
- Other micro litter found included two synthetic fibres, one hard fragment and one glass fragment.

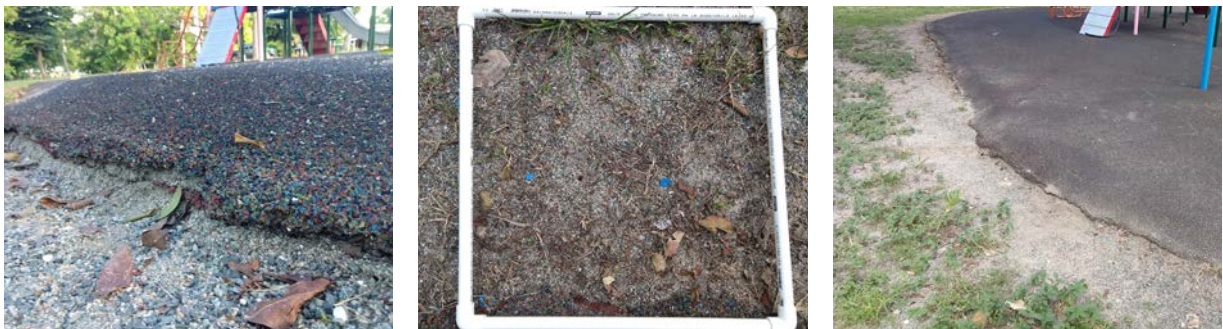
Sampling was conducted between the 10 - 18/04/2021. Minor rainfall occurred (5-10 mm) in the 72h before sampling. The condition of the play surface was graded as deteriorated with obvious signs of cracking. A shade cloth covered the site. Twelve cores (8 cm diameter x 2 cm depth) were taken at 0 m, 2 m and 4 m away from the play area.

- Moderately high rubber crumb loss close to the play area and proportional declines at distances away from the site
- Shading may be reducing deterioration rates and grass adjoining the area further limits movement of rubber away
- Rubber was mostly 1 – 5 mm in size and a mixture of blue, black, red and yellow colours
- A small amount of other microlitter was found including hard fragments, synthetic fibres, glass and metal.
